IMPACT ASSESSMENT OF WATER RESOURCE MANAGEMENT (WRM) STRUCTURES UNDER COASTAL AREA DEVELOPMENT PROJECT IN SAURASHTRA COASTAL AREAS

Final Report

Prepared By
Arid Communities and Technologies
Bhuj-Kachchh

October, 2013

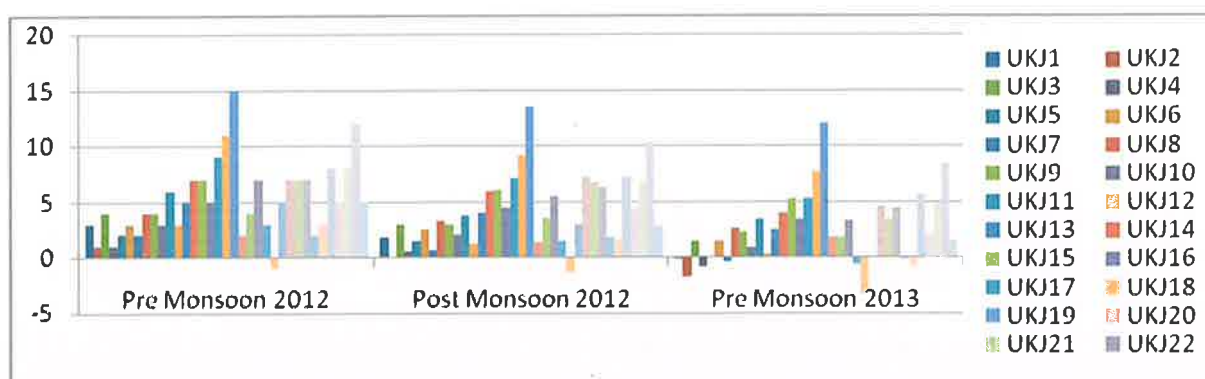
Fig. 2.3 Well Hydrographs Showing Pre and Post Monsoon Changes in RWLs in Observations Wells of Village Khajudra Year 2012, 2013

- Water levels in observation wells have gradually depleted from pre monsoon season of year 2012 to pre monsoon season of year 2013. The same observation can be judged through decreasing area of 10-15 WL zone in Iso- RWL map (Fig. 2.4) and in hydro graph where reduced water levels in some of the observation wells have lowered down below AMSL. (Fig. 2.3)
- As far as water quality is concern there is no any significant changes in TDS concentrations have observed during these three seasons. (Fig. 2.6)
- It is important to mentioned, that the structure has not filled with its full capacity due to low rainfall during year 2012. •
- Another important justification is the two years monitoring for impact assessment is too early to draw robust conclusions about impact.

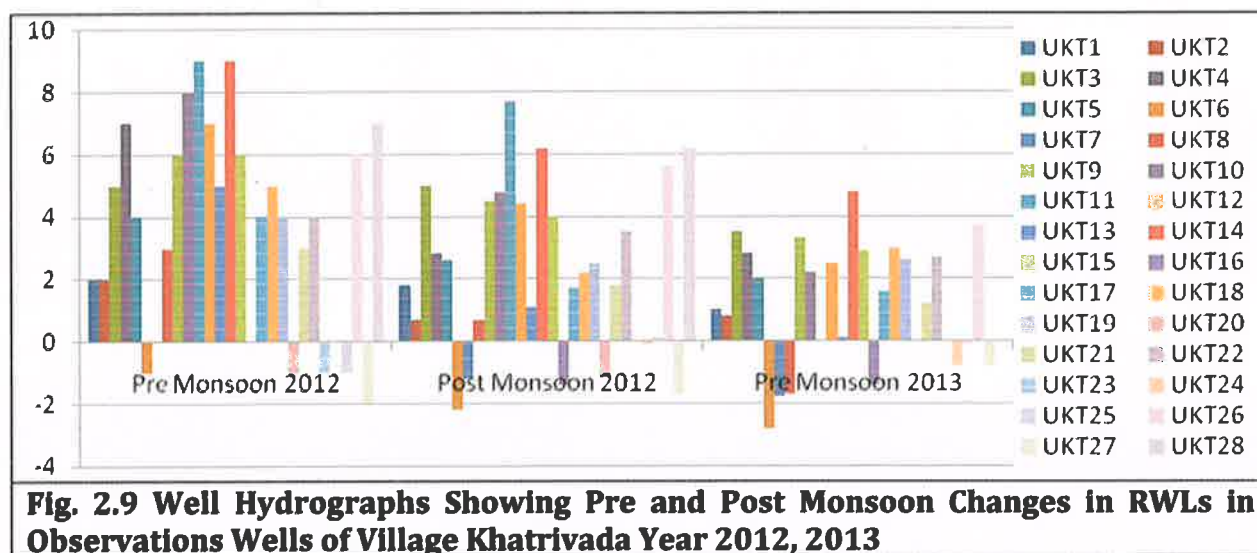
Fig. 2.9 Well Hydrographs Showing Pre and Post Monsoon Changes in RWLs in Observations Wells of Village Khatrivada Year 2012, 2013

- Water levels in observation wells have gradually depleted from pre monsoon season of year 2012 to pre monsoon season of year 2013. This can observe by comparing RWL in table 2.16, well hydrograph (Fig. 2.9) and iso RWL maps (Fig. 2.10). It can say that groundwater level having 5 to 10 m height above MSL has been disappeared in year 2013.
- As far as water quality is concern there is degradation in water quality in term of TDS. Based on ISO TDS map (Fig. 2.12), it can clearly say that water quality zone (<2000 mg/l TDS) has disappear from pre monsoon 2012 to 2013.
- Therefore, water table and TDS based data analysis did not show any positive impact of the structure on groundwater regime of the study area.
- Another important justification is that, two years monitoring for impact assessment is too early to draw robust conclusions about impact.

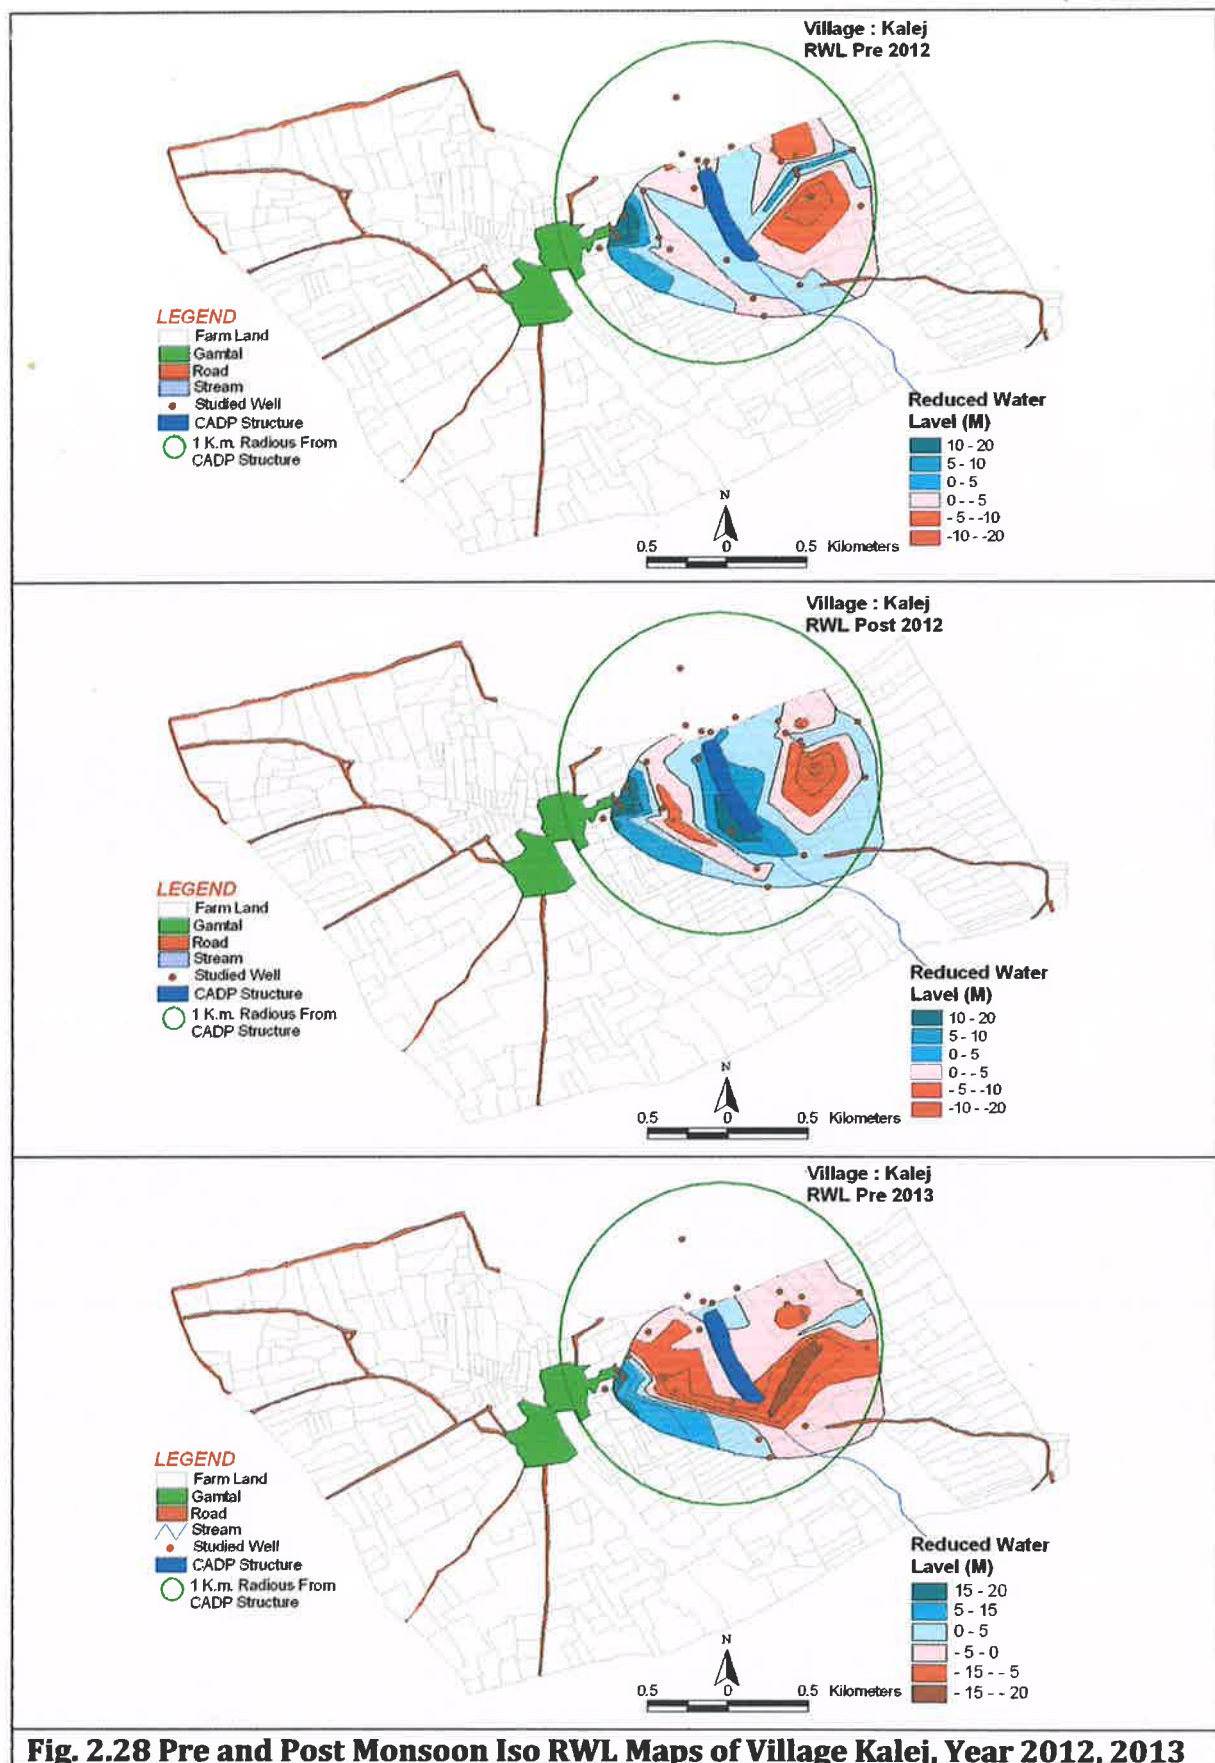
Fig. 2.28 Pre and Post Monsoon Iso RWL Maps of Village Kalej, Year 2012, 2013

- Iso RWL maps shows there is a subsurface low conditions take place in eastern part of the structure whereas subsurface high condition remains almost same in western part of the structure.

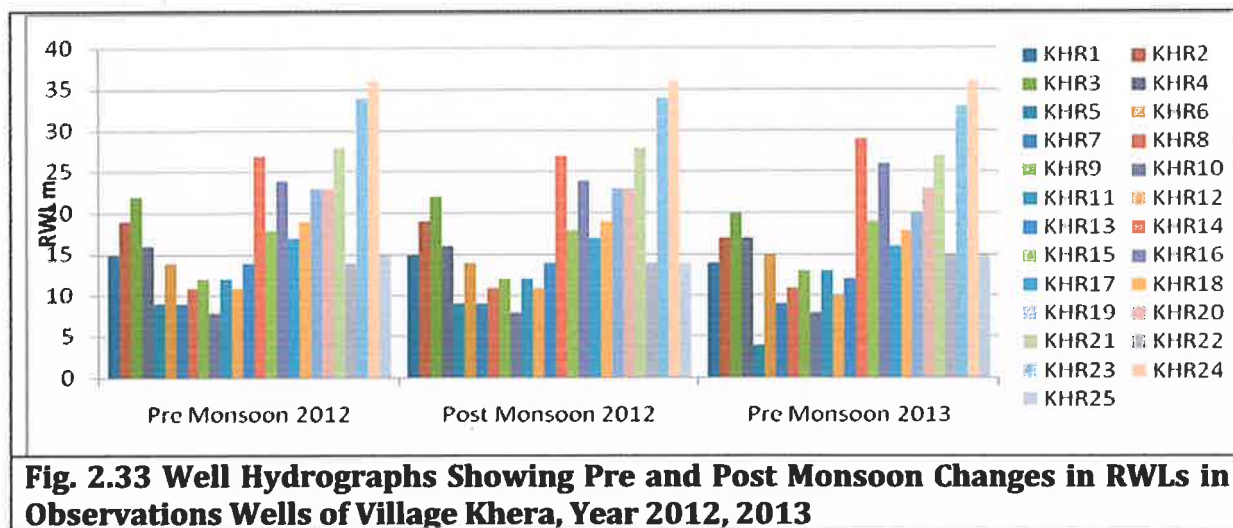
Fig. 2.33 Well Hydrographs Showing Pre and Post Monsoon Changes in RWLs in Observations Wells of Village Khera, Year 2012, 2013

- Raise in water levels up to 1 m has observed in OWs no 4,6,9,11, and 22 whereas 2 m rise in OW no 16 from pre monsoon season of year 2012 to pre monsoon season of year 2013 (Fig. 2.33 and Table 2.49)
- Similarly decrease in TDS concentrations (more than 160 ppm) in pre to pre monsoon seasons has observed in OW no 6, 12 and 22.
- Iso-RWL maps shows increasing areas of subsurface low conditions in north of the structure i.e. RWL zone of 5-10 m (Fig. 2.34)
- Further Iso-RWL maps clearly shows water table remain maintained withing RWL zone of 20-30 m in immediate area of CADP WRM structure. This stable situation may be due to groundwater flows in to this zone from all directions. (Fig. 2.35)

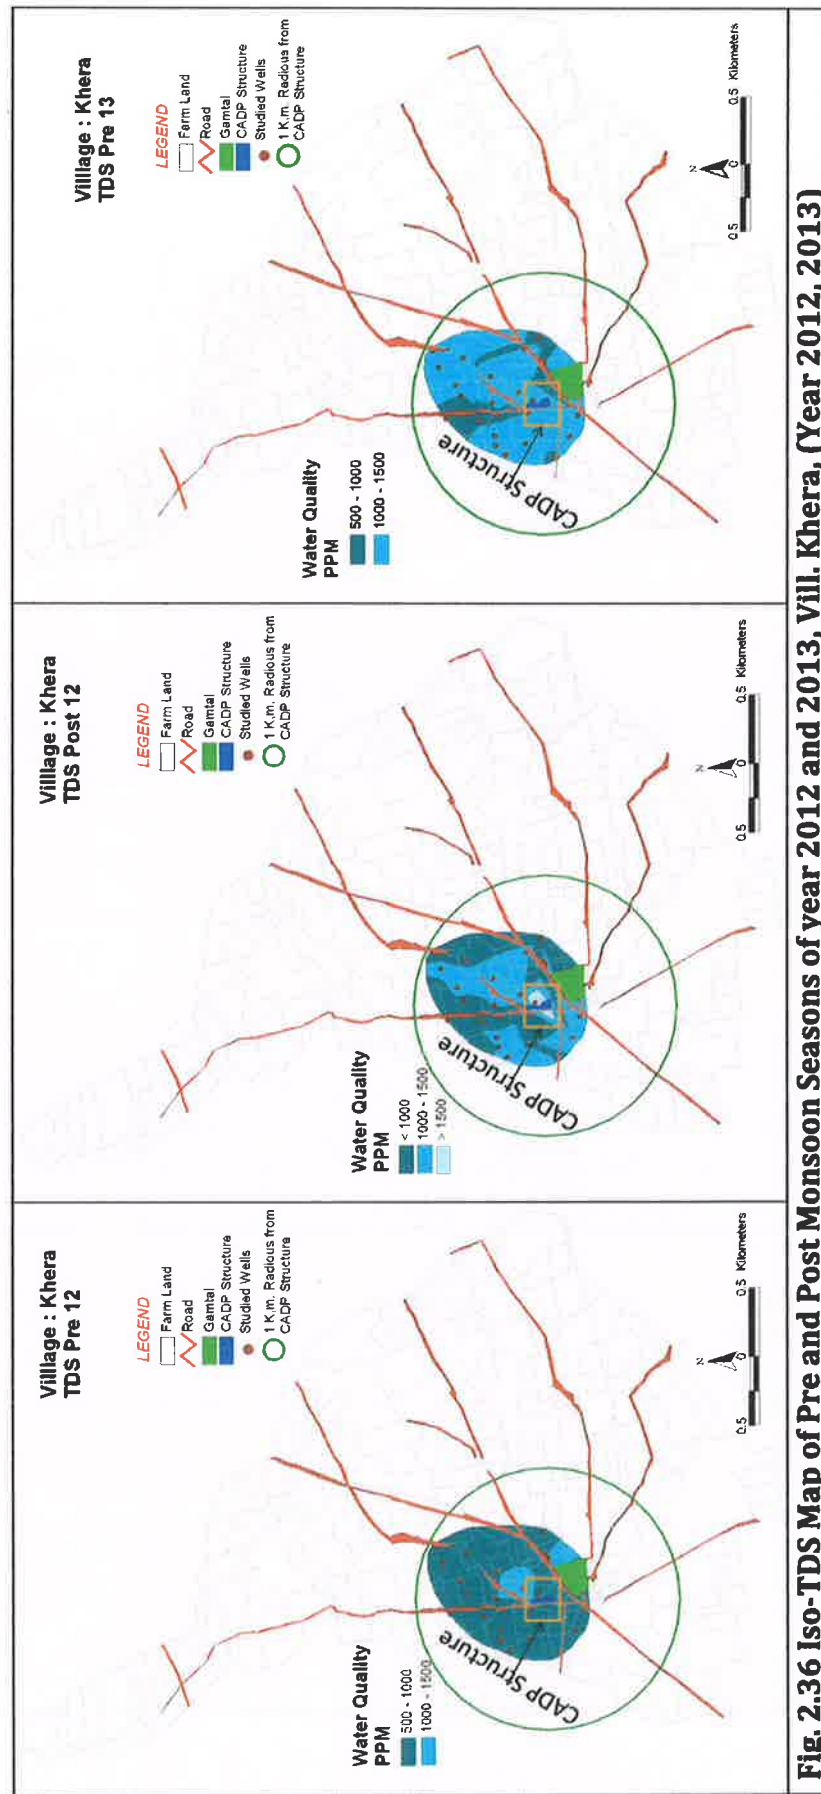
Fig. 2.36 Iso-TDS Map of Pre and Post Monsoon Seasons of year 2012 and 2013, Vill. Khera, (Year 2012, 2013)

- Iso TDS zoning shows in all the seasons TDS remains less than 1500 ppm however, in post monsoon season of year 2012 in some area the concentration increases more than 1500 ppm, even though the maximum TDS concentration in the area is not more than 2000 ppm

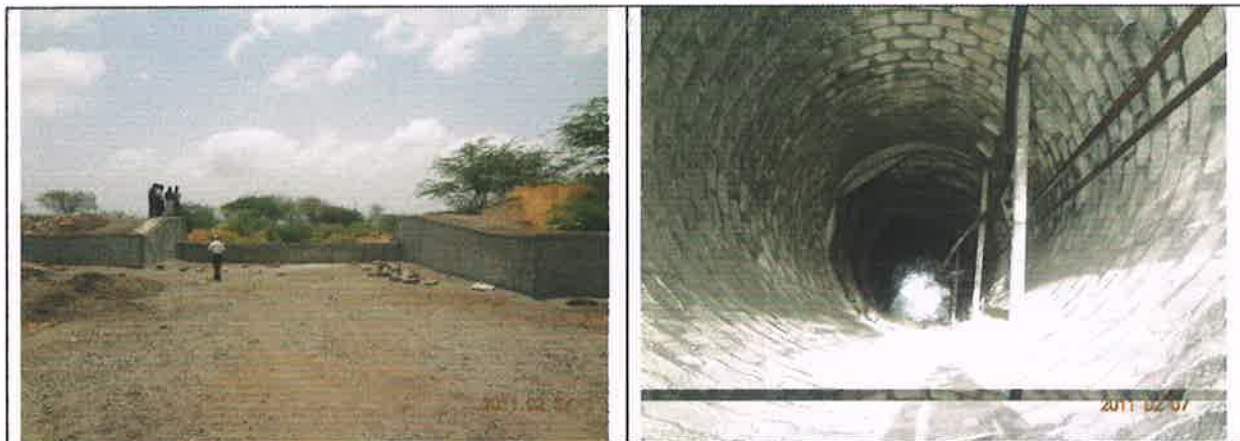
**Plate 2.7 Photographs show WRM Structure and Water Level in Observation Well**

Due to failure due to leakage of structure in Ganjavadar village it is very difficult to assess impact of structure in Ganjavadar. However depleting trend of RWL is may be regular withdrawal of groundwater. Similarly there is also very marginal changes have seen all are on account of regular use of groundwater.

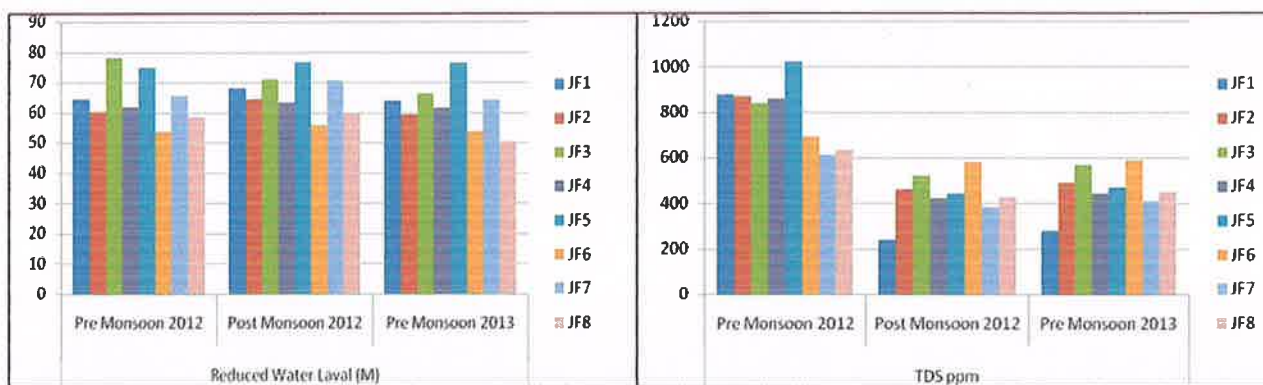
Fig. 2.55 Seasonal Changes in (A) Water Levels and (B) TDS Concentrations in Wells of Fachariya (Year 2012,13)

- Significant changes in groundwater quality has seen in all the wells from pre monsoon of year 2012 to same of year 2013
- Water level condition except few wells shows almost stable condition.
- In general water quality in wells is very good for all the seasons and it is within permissible limits of TDS concentrations for drinking water.
- According to village people the water level before the structure was at 13.5 m that now raised upto at 3.5 m
