IMPACT ASSESSMENT OF WATER RESOURCE MANAGEMENT (WRM) STRUCTURES UNDER COASTAL AREA DEVELOPMENT PROJECT IN SAURASHTRA COASTAL AREAS

Final Report

Prepared By
Arid Communities and Technologies
Bhuj-Kachchh

October, 2013

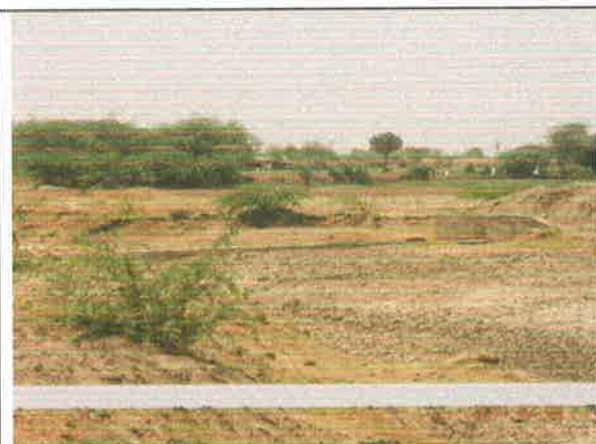
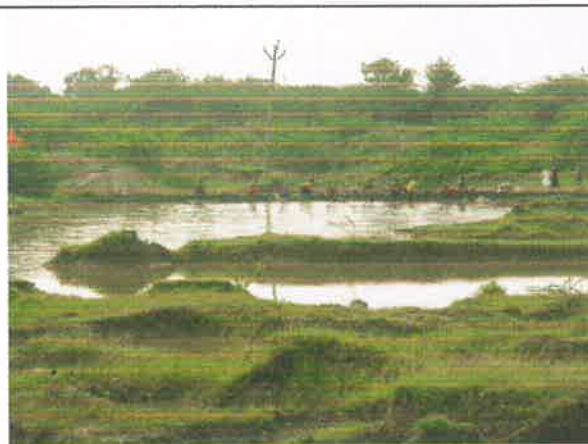
Plate 2.1 Waste Weir Construction in Existing Pond, Village Khajudra

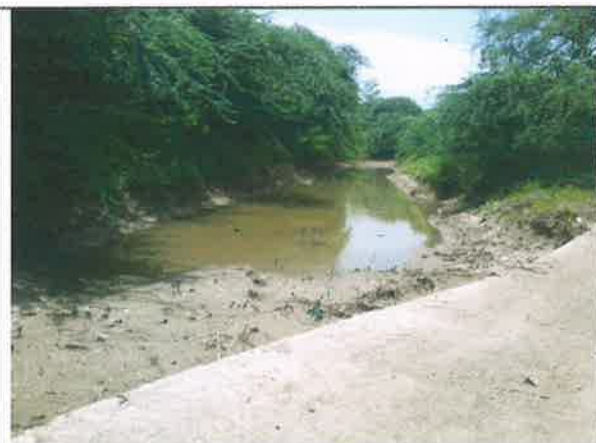
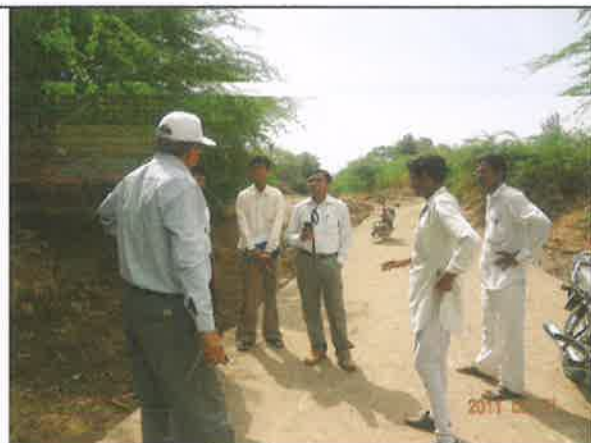
Plate 2.2 Check Dam Construction in Khatrivada village

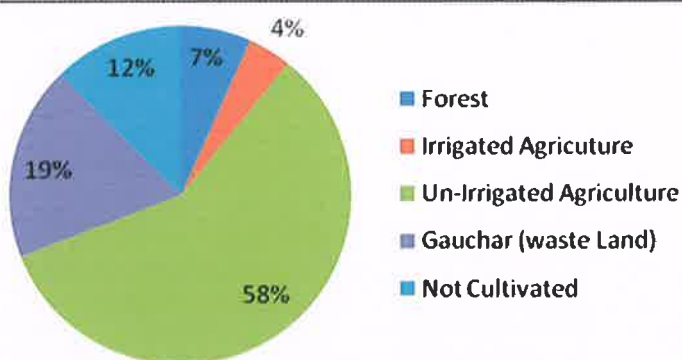
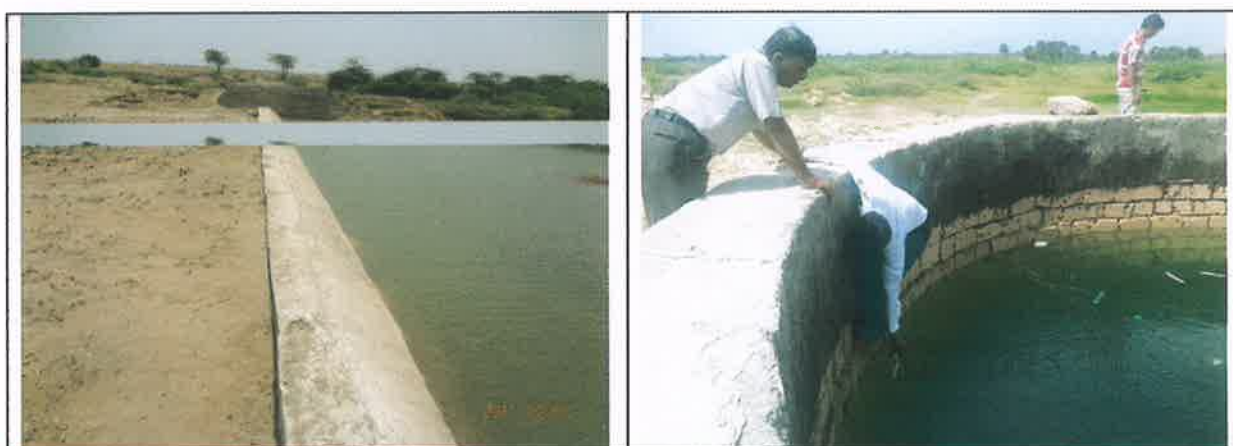
Plate 2.3 Photographs showing WRM Structure and Nearby Open Well

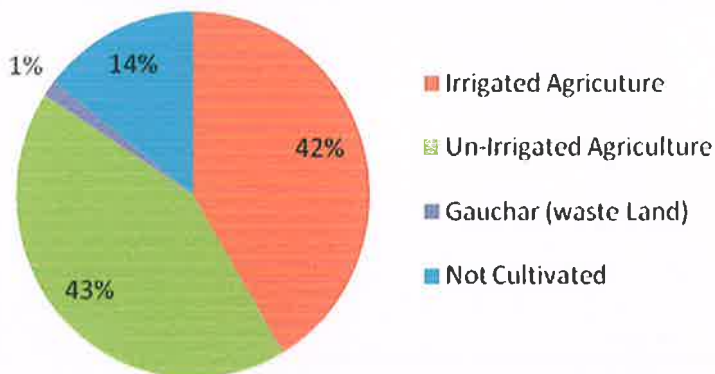
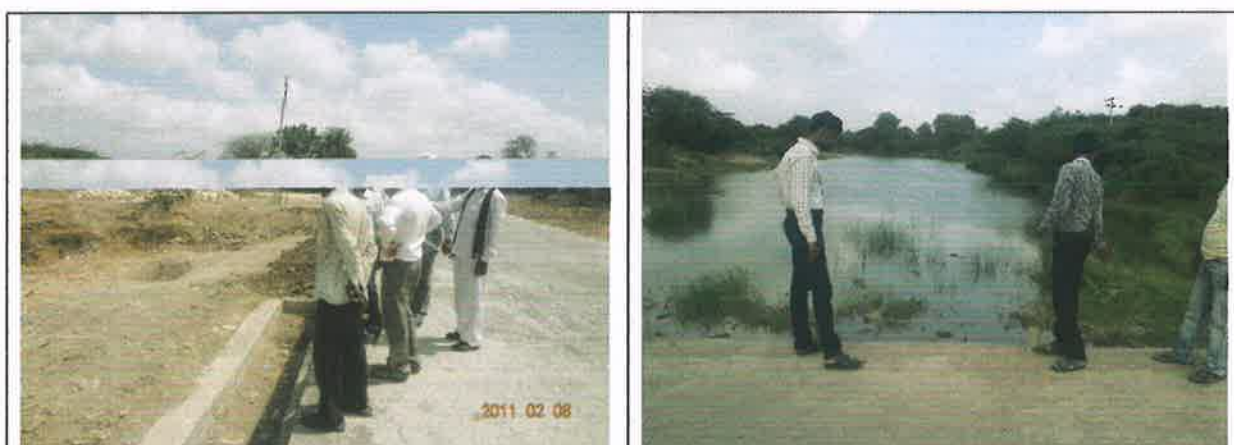
Plate 2.4 Photographs showing WRM structure before and after Monsoon

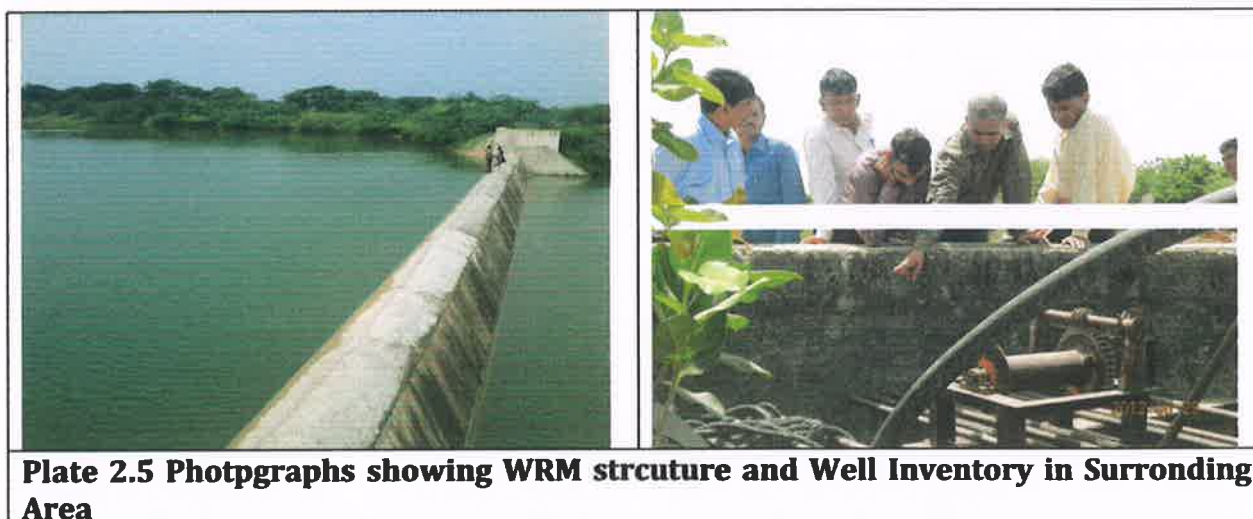
**Plate 2.5 Photographs showing WRM structure and Well Inventory in Surrounding Area**

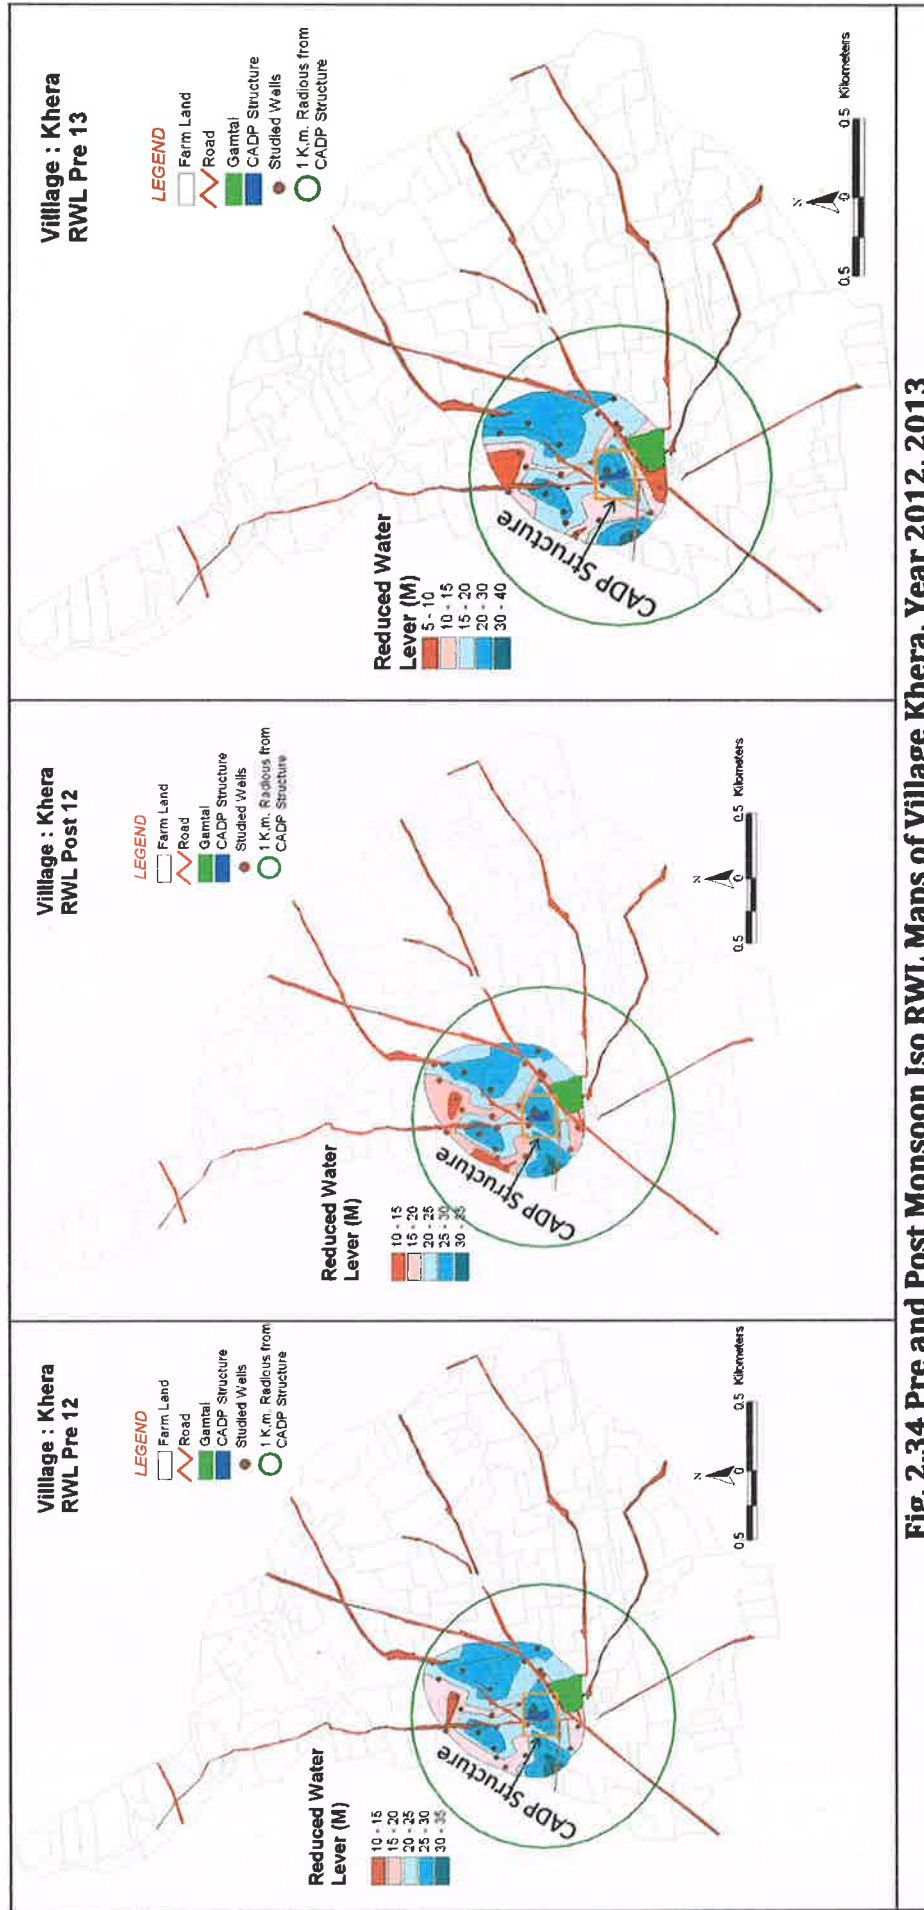
Fig. 2.34 Pre and Post Monsoon Iso RWL Maps of Village Khera, Year 2012, 2013

Impact on Groundwater: Impact on groundwater due to implementation of percolation tank in village Khera has assessed with different methods i.e. by computing hydro-graphs (Fig. 2.33), preparation of trend showing maps such as Iso RWL maps (Fig. 2.34), Iso TDS (Fig. 2.36) maps and map of groundwater flow direction (Fig. 2.35) as well as comparative analysis of water levels and water quality in different seasons. In addition to all this approaches people's view have also considered for observed changes. Following are major impacts observed in village Khera after the construction of structure.

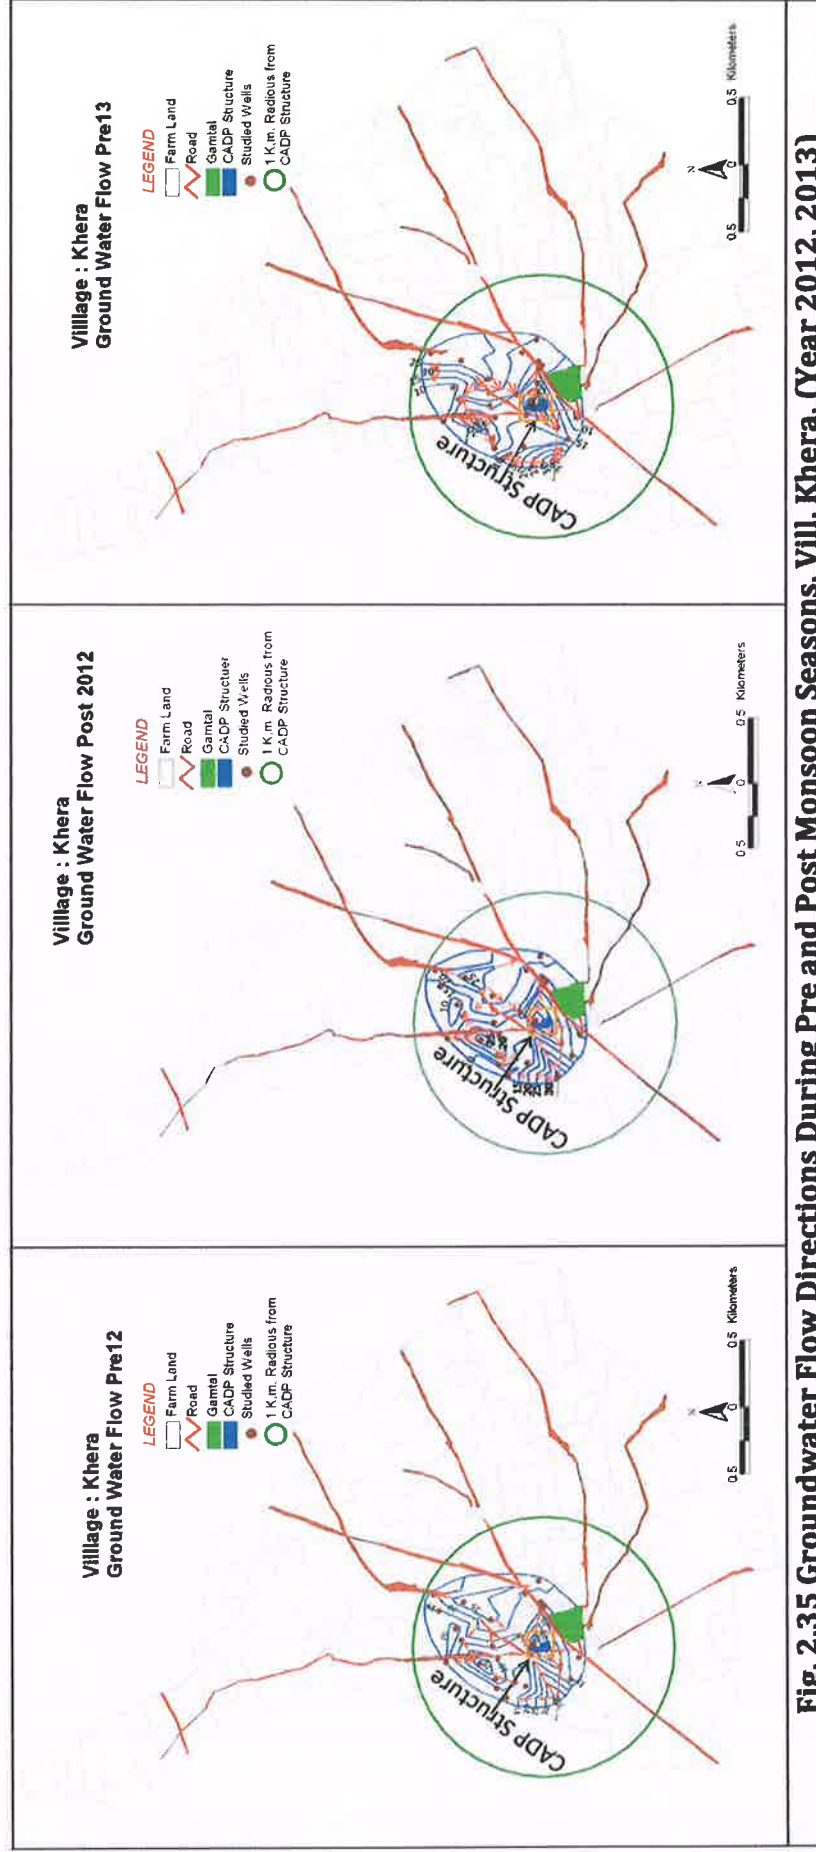
Fig. 2.35 Groundwater Flow Directions During Pre and Post Monsoon Seasons, Vill. Khera, (Year 2012, 2013)

- Raise in water levels up to 1 m has observed in OWs no 4,6,9,11, and 22 whereas 2 m rise in OW no 16 from pre monsoon season of year 2012 to pre monsoon season of year 2013 (Fig. 2.33 and Table 2.49)
- Similarly decrease in TDS concentrations (more than 160 ppm) in pre to pre monsoon seasons has observed in OW no 6, 12 and 22.
- Iso-RWL maps shows increasing areas of subsurface low conditions in north of the structure i.e. RWL zone of 5-10 m (Fig. 2.34)
- Further Iso-RWL maps clearly shows water table remain maintained withing RWL zone of 20-30 m in immediate area of CADP WRM structure. This stable situation may be due to groundwater flows in to this zone from all directions. (Fig. 2.35)

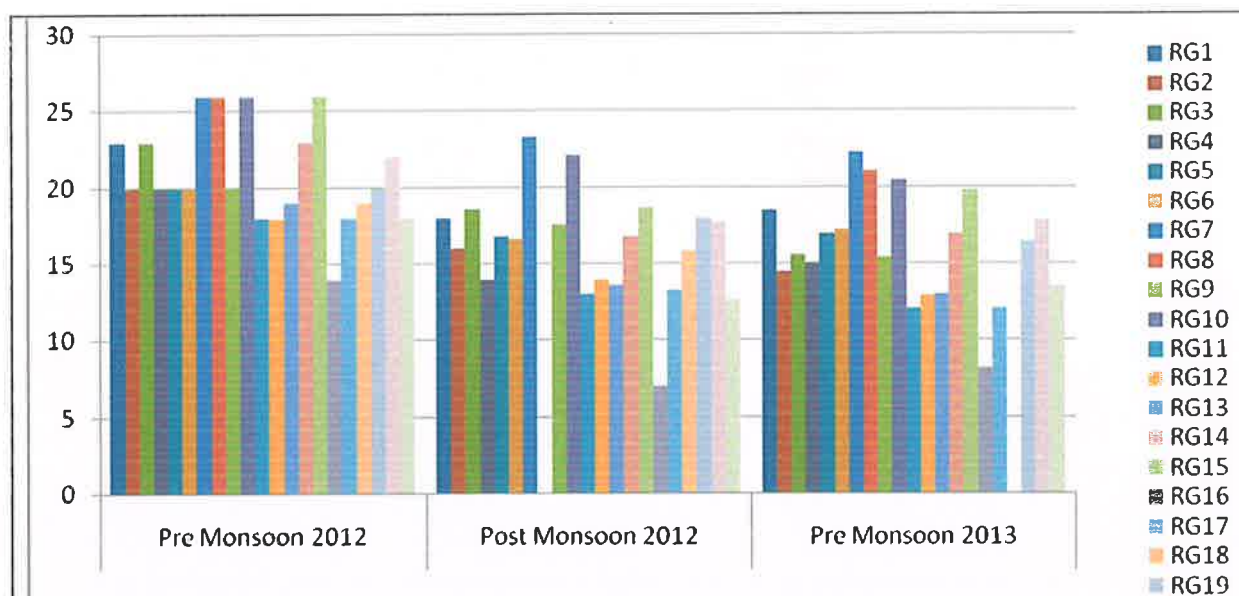
Fig. 2.39 Well Hydrographs Showing Pre and Post Monsoon Changes in RWLs in Observations Wells of Village Ganjavadar, Year 2012, 2013

Due to failure due to leakage of structure in Ganjavadar village it is very difficult to assess impact of structure in Ganjavadar. However depleting trend of RWL is may be regular withdrawal of groundwater. Similarly there is also very marginal changes have seen all are on account of regular use of groundwater.

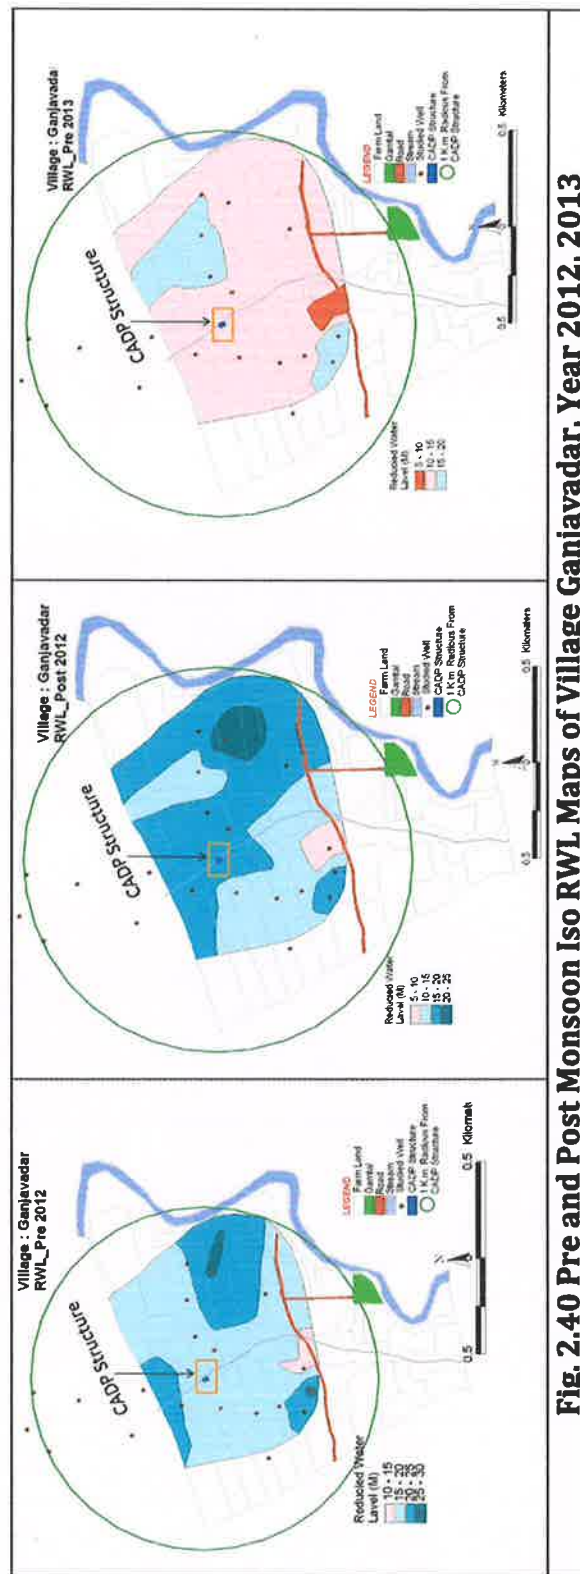
Fig. 2.40 Pre and Post Monsoon Iso RWL Maps of Village Ganjavadar, Year 2012, 2013

Impact on Groundwater: Impact on groundwater due to implementation of spill way in village Ganjavadar has assessed with different methods i.e. by computing hydro-graphs (Fig. 2.39), preparation of trend showing maps such as Iso RWL maps (Fig. 2.40), Iso TDS (Fig. 2.42) maps and map of groundwater flow direction (Fig. 2.41) as well as comparative analysis of water levels and water quality in different seasons. In addition to all this approaches people's view have also considered for observed changes. Following are major impacts observed in village Ganjavadar after the construction of structure.

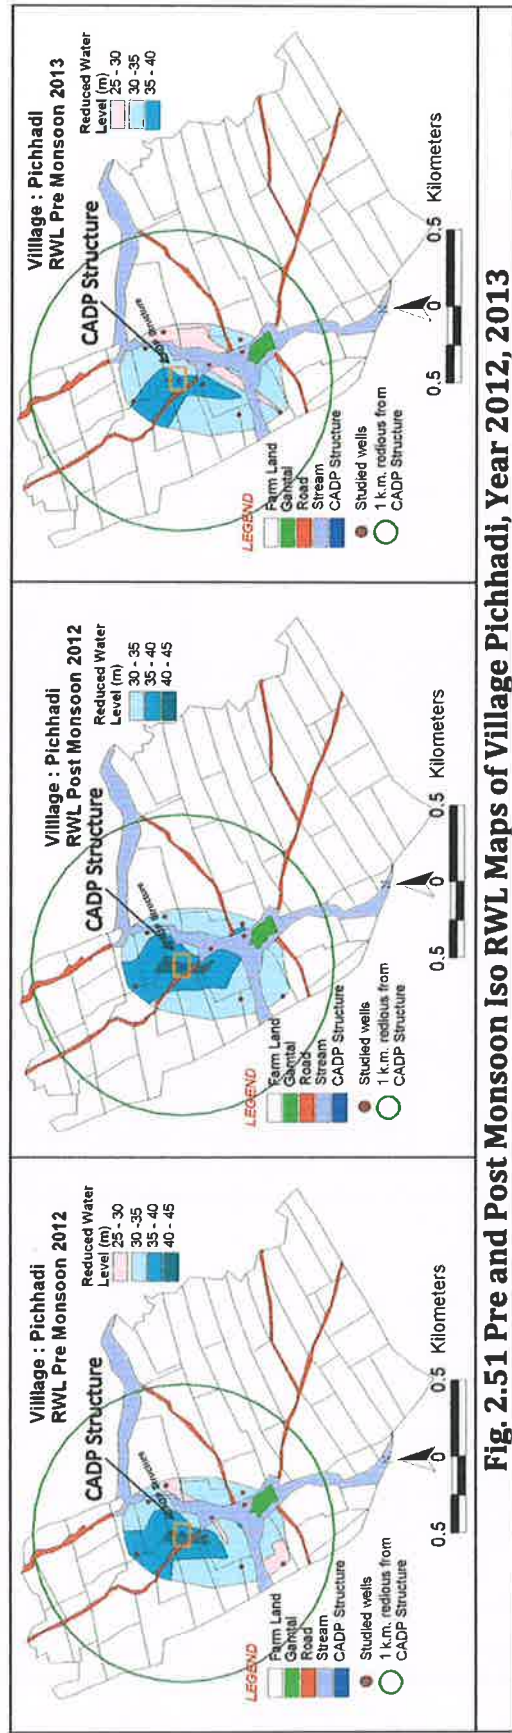
Fig. 2.51 Pre and Post Monsoon Iso RWL Maps of Village Pichhadi, Year 2012, 2013

Analysis of observation records has carried out with the help of computation of hydrograph and various trend showing maps such as Iso - RWL (Fig. 2.51) and Iso - TDS (Fig. 2.52) maps. In addition to this exercise consultations with farmers have also held to verify the analysis. Following are main impacts have observed in groundwater

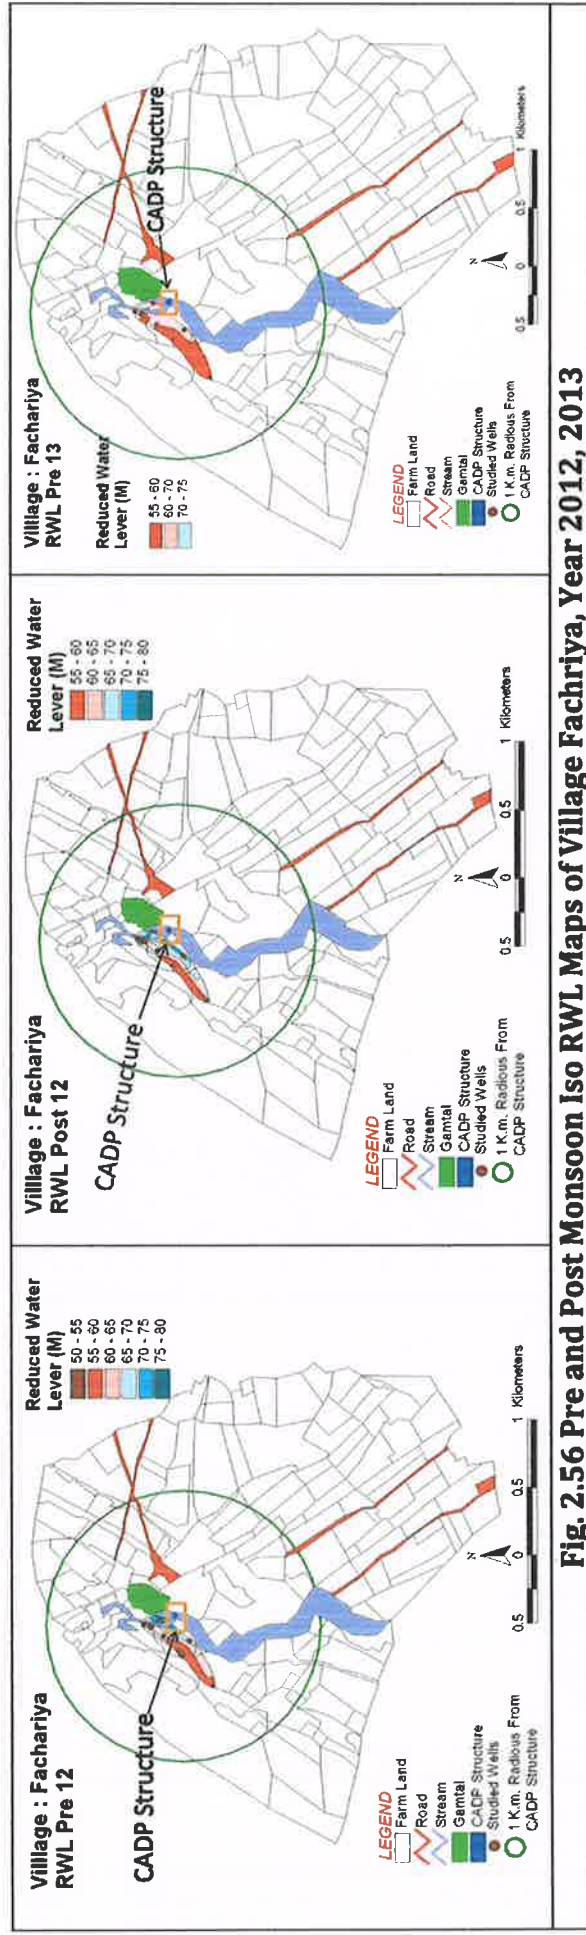
Fig. 2.56 Pre and Post Monsoon Iso RWL Maps of Village Fachariya, Year 2012, 2013

- Significant changes in groundwater quality has seen in all the wells from pre monsoon of year 2012 to same of year 2013
- Water level condition except few wells shows almost stable condition.
- In general water quality in wells is very good for all the seasons and it is within permissible limits of TDS concentrations for drinking water.
- According to village people the water level before the structure was at 13.5 m that now raised upto at 3.5 m
